The wrong way to restore an implant

By Chris Salierno, DDS

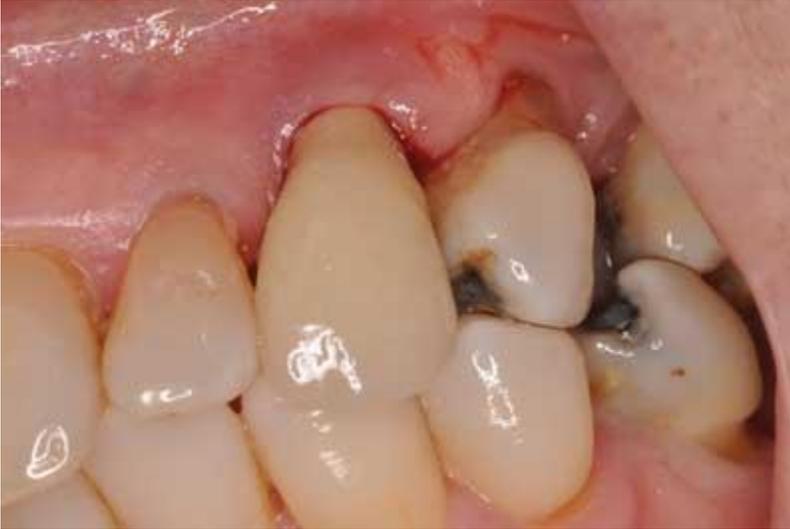
A new patient presents to my office with a chief complaint: “My implant crown fell off yesterday.” She’s a 72-year-old woman with noncontributory medical history. She states the implant in tooth position No. 11 was placed “a few years ago and never felt right.” Examination reveals a prefabricated abutment of some sort that is not mobile. Curiously, the peri-implant gingiva has a slight erythema. Moderate bleeding is noted upon insertion of the implant crown.

Fig. 1: Implant crown seated.

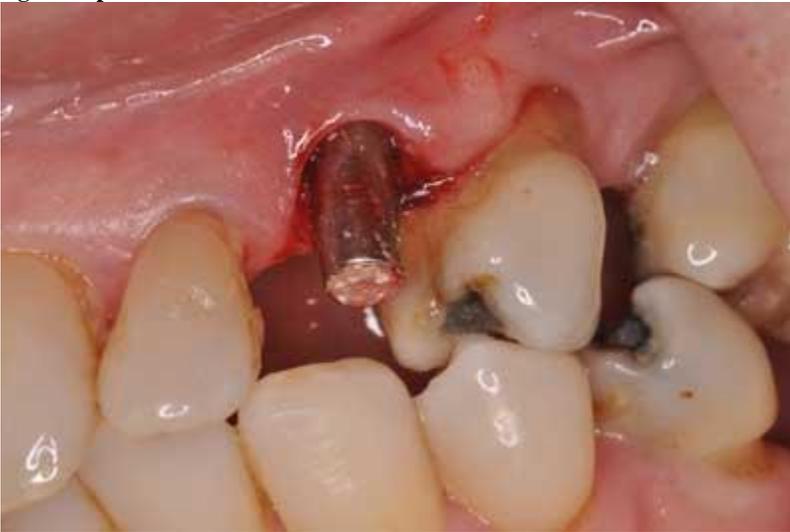
Fig. 2: Moderate bleeding noted around prefabricated abutment after crown is removed.

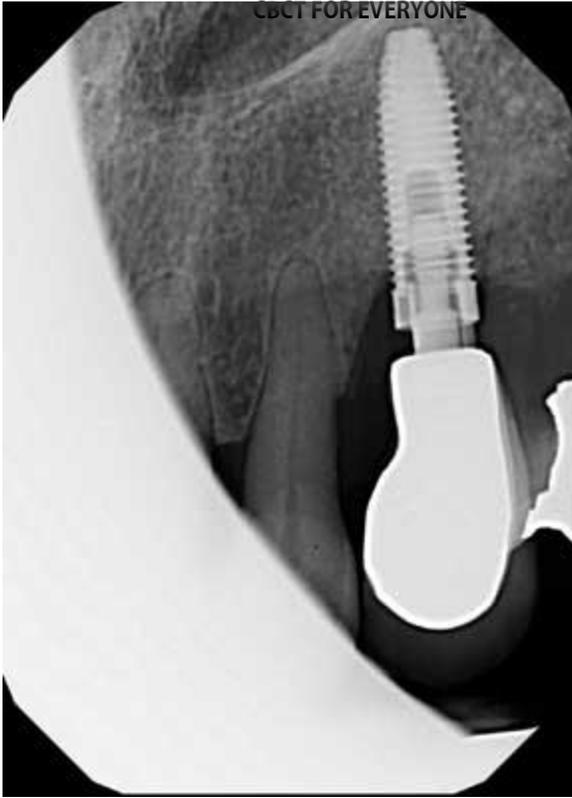
Fig. 3: Periapical radiograph.

Looks like the original restorative dentist never fully seated the abutment! Perhaps that would explain why the patient believed the crown “never felt right.” We remove the abutment and see that there are no restorative margins to speak of, just a standard, prefabricated abutment that was used right out of the package. Since there is no sign of radiographic bone loss, the gingival erythema is diagnosed as peri-implant mucositis.

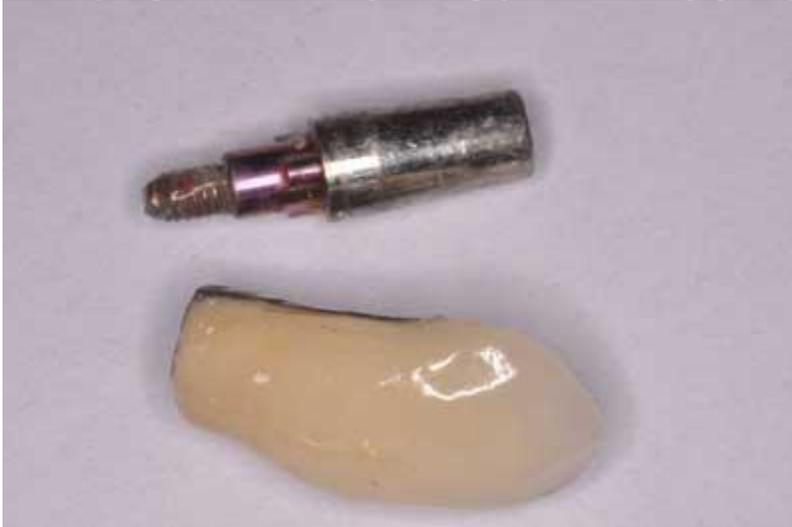
Fig. 4: Abutment and crown.

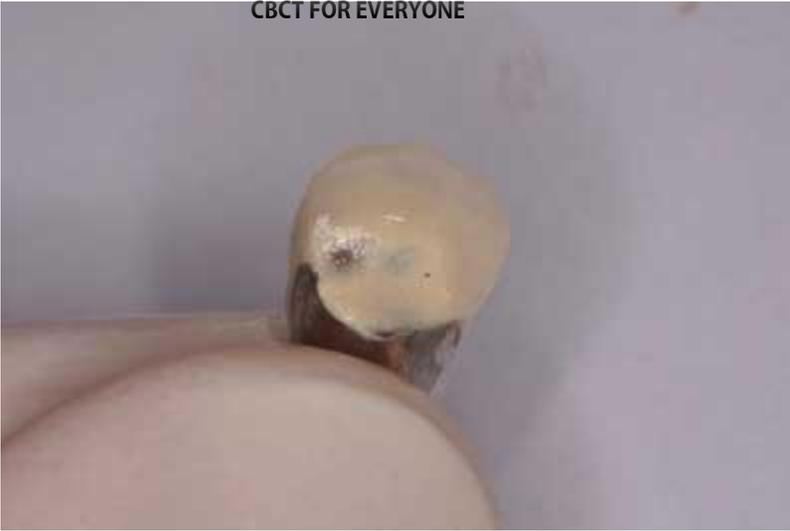
Fig. 5: Lingual surface of crown.

So the dentist torqued down a nonseated abutment, then wondered why the crown was too high. Then he or she probably blamed the lab for making a “bad” crown and ground down the porcelain until the patient could fully occlude. Oh, boy.

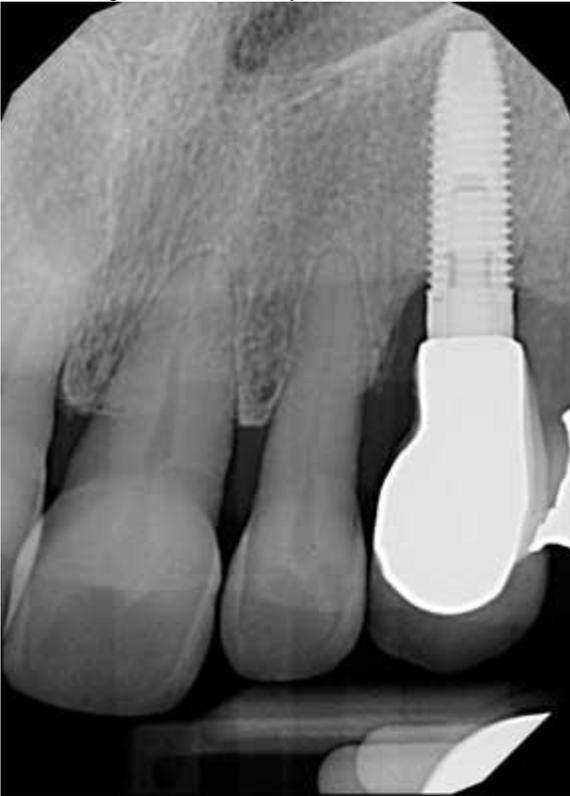
Fig. 6: Periapical radiograph after correct seating of components.

I choose to keep the abutment and crown, seat them correctly, cement the crown with a retrievable cement, and monitor the patient in two weeks. After seating the abutment fully, I seat the crown and take a radiograph for confirmation.

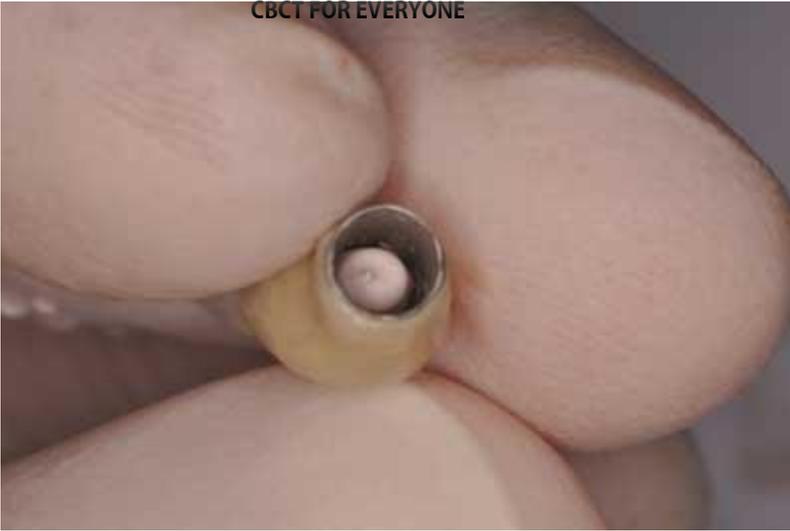
Fig. 7: A small amount of implant cement applied inside the crown.

A temporary cement (Premier Implant Cement) is selected so that the restoration will be retrievable if and when necessary. This cement is also radiopaque so as to allow radiographic detection of any excess. A small amount is applied to the internal aspect of the crown. An implant-friendly scaler made of graphite (Premier Universal Implant Scaler) is used to remove any excess cement after seating. Bleeding is anticipated due to the original erythema that was present.

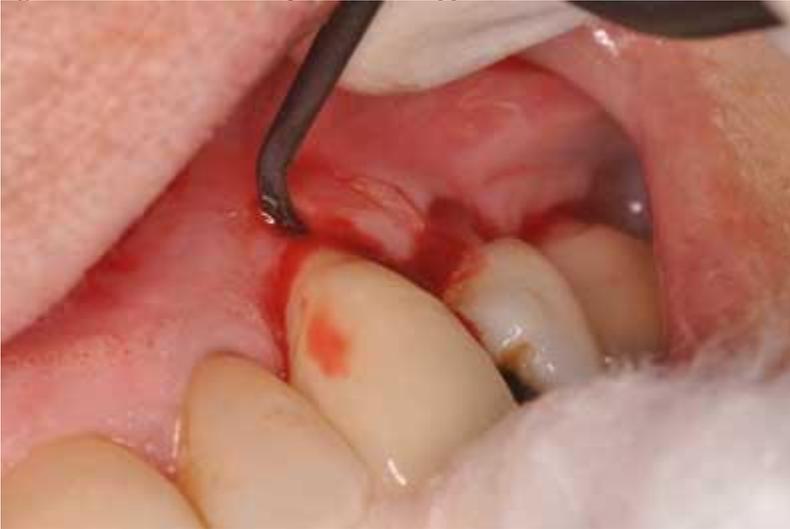
Fig. 8: A graphite scaler can remove any excess cement. Bleeding is visible due to the peri-implant mucositis.

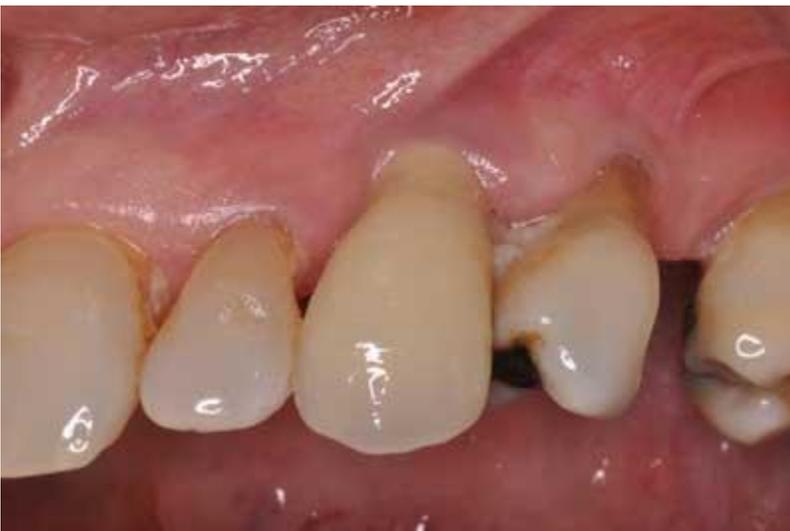
The patient returns for a two-week follow-up and the gingival erythema is absent. Oral hygiene instruction is reviewed as there is still visible plaque on the adjacent teeth. Probing of the implant reveals no bleeding, thus the peri-implant mucositis appears to have been successfully treated.

Fig. 9: Two weeks after initial presentation, peri-implant mucositis appears to have subsided.
